Manhole Inspection Summary

Manhole # S27E__005MH

Insp Date: **5/26/09 3:27 PM**

Location Address: **859 LEXINGTON ST**

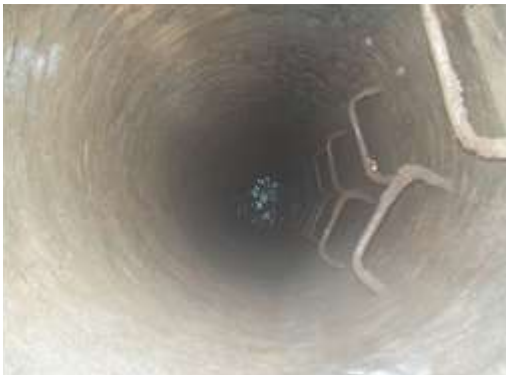
Defect 4

Surcharge ☒ **Evidence Of Surcharge** Depth: **10** (ft.) ☐ Active Surcharge Present

evidence of ASUR

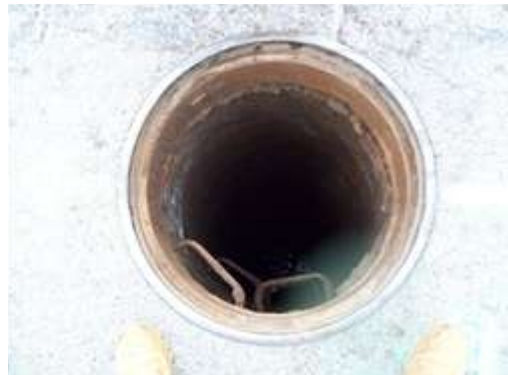
Defect 3

corroded steps

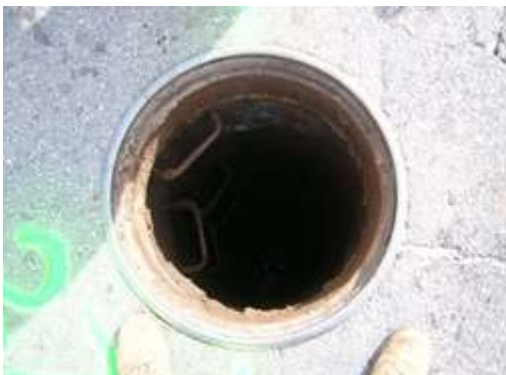
Defect 1

Condition: ☐ Sound ☒ **Cracked** ☐ Root Intrusion ☒ **Loose Brick** ☒ **Deteriorated**

cracked chimney

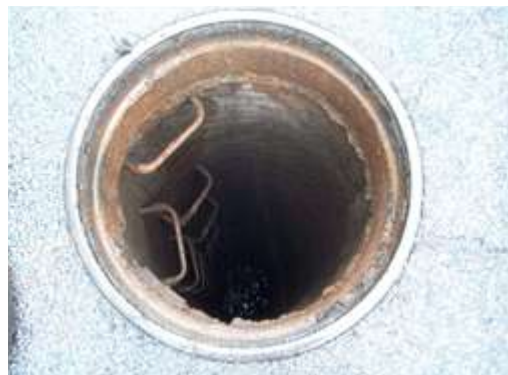
Defect 2

loose bricks, deteriorated

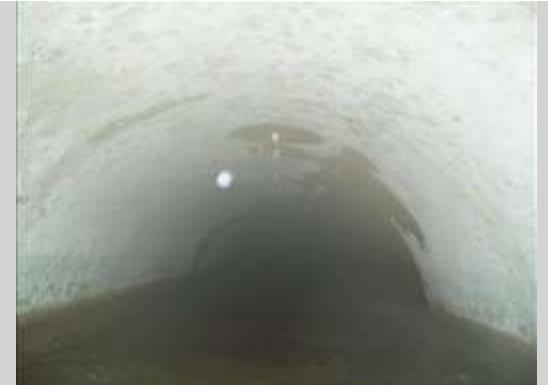
12 O'Clock Outflow

60 in. Circular Gravity Sewer
Pipe Out @ 12 O'Clock

Pipe Height: (in.) Direct
Pipe Material: **Concrete** ☐ Pipe Lined
Invert Depth: **33.23** (ft.) Flow Characteristics: **Fast**
Deposits: ☒ None ☐ Mud ☐ Sludge ☐ Debris ☐ Grease
Silt Depth: (in.) Deposits Extent:
Infiltration: **None** Pipe Seal Cond: **Sound**

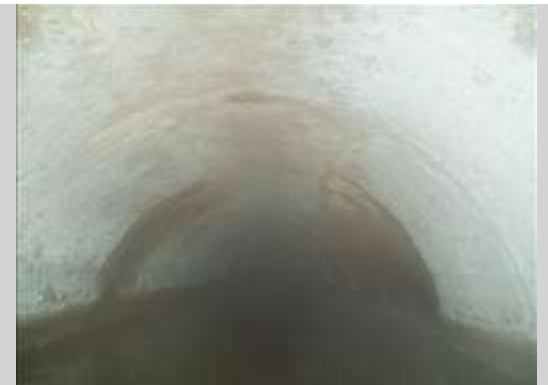
6 O'Clock Inflow

60 in. Circular Gravity Sewer
Pipe In @ 6 O'Clock

Pipe Height: (in.) Direct
Pipe Material: **Concrete** ☐ Pipe Lined
Invert Depth: **33.24** (ft.) Flow Characteristics: **Fast**
Deposits: ☒ None ☐ Mud ☐ Sludge ☐ Debris ☐ Grease
Silt Depth: (in.) Deposits Extent:
Infiltration: **None** Pipe Seal Cond: **Sound**
